Manhole Inspection Summary

Manhole # S33EE_032MH

Location Address: **1203 MARTIN LUTHER KING JR BLVD** Cross Street: **BIDDLE ST**

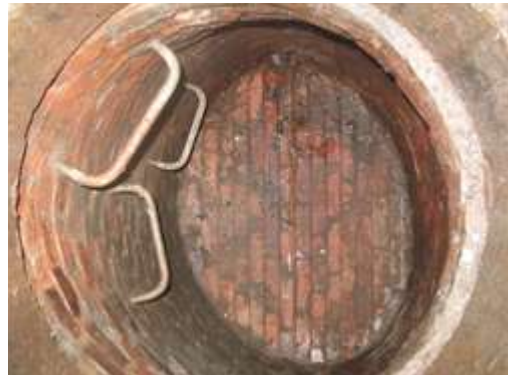
Top View

Corbel and Barrel infiltration. Channel debris.

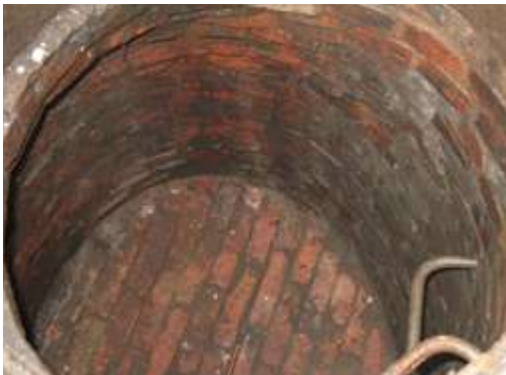
Defect

Frame leaks. Frame offset. Adjustment deterioration and infiltration. Corbel infiltration - other side.

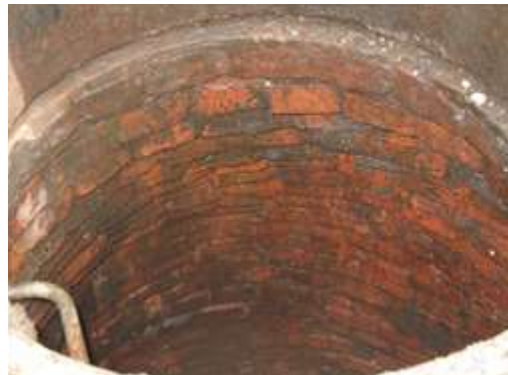
Defect

Frame leaks. Frame offset. Adjustment deterioration and infiltration. Corbel infiltration.

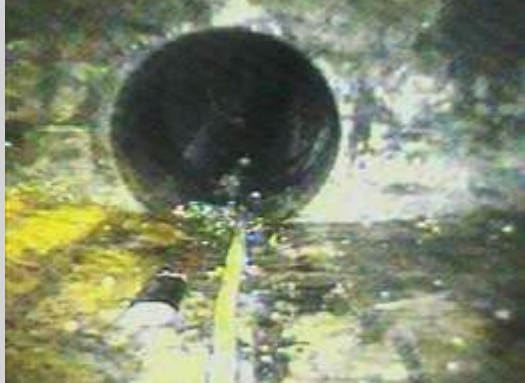
8 in. Circular Gravity Sewer
Pipe Out @ 12 O'Clock

Deposits: ☐ None ☐ Mud ☐ Sludge ☒ **Debris** ☒ **Grease**

Silt Depth: **0** (in.) Deposits Extent: **Light**
